Exhibit F

Degradation of polypropylene in vivo: a microscopic analysis of meshes explanted from patients

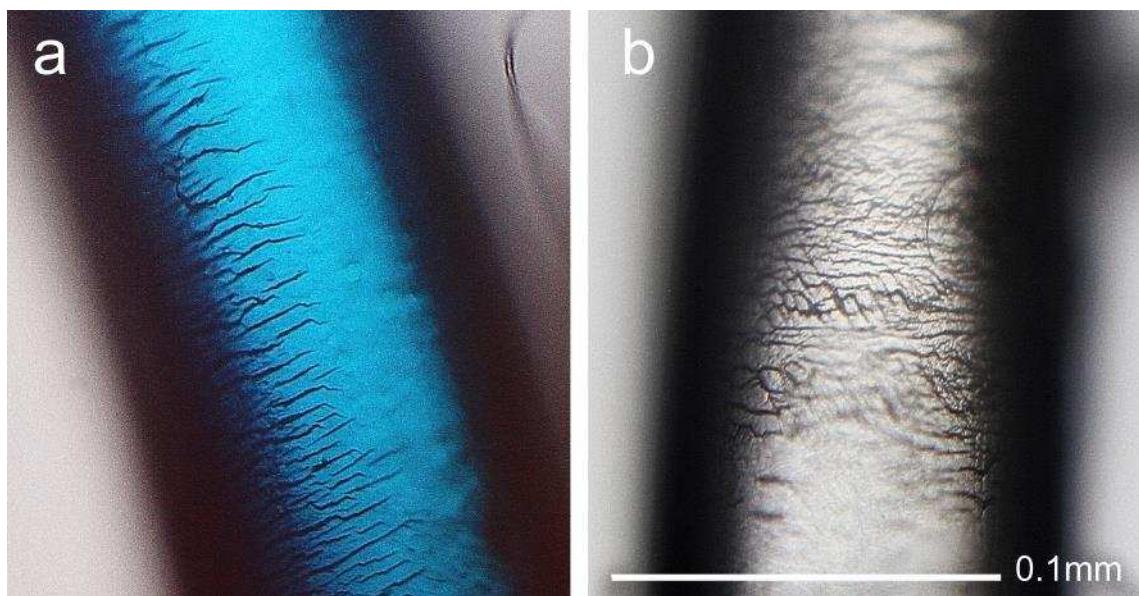
45
46 In one case the mesh fibers could be assessed immediately after explantation, before
47
48 tissue drying or fixation in formalin. The transvaginal sling was excised because of
49
50 chronic pain 9 years after implantation. Mesh fibers at the specimen edges were free of
51
52 tissue and could be examined in a conventional microscope after a rinse in saline and
53
54 without additional preparation [Figure 1]. There were transverse cracks at the bending
55
56

1
2
3 points [Figure 1(a)] and patches of haphazard cracks on straighter portions of the fibers
4
5 [Figure 1(b)].
6
7

FIGURE 1. Surface of the mesh fibers immediately after explantation from the body, transvaginal sling explanted due to pain 9 years after implantation, light microscope, 20x objective with image crop. Mesh fibers at the specimen edges had no covering tissue and could be examined as they were in the body, avoiding possible artifacts of tissue removal, drying or contact with formalin. Both blue (a) and clear (b) fibers showed surface cracking.

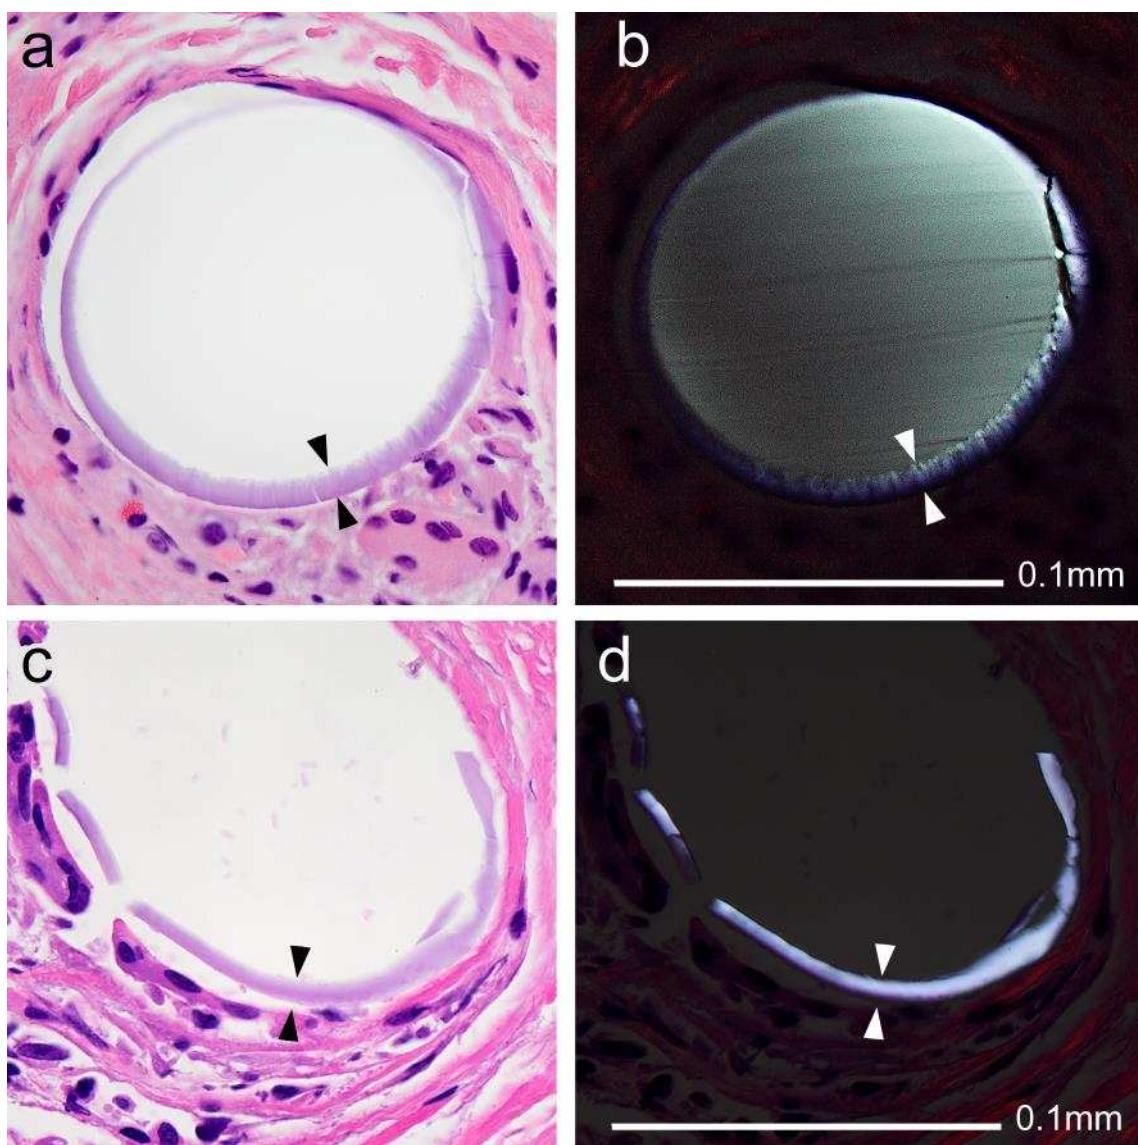
8 Microscopic examination of mesh fibers cross-sectioned in the histological slides
9 showed a circumferential outer layer of degraded polypropylene in 162 of 164 examined
10 explants [Figure 2(a)]. Polypropylene degradation was observed across a large range of
11 devices, produced by different manufacturers, explanted from different anatomical
12 locations and due to different clinical complications [Table 1]. The only two specimens
13 where the degradation layer was not visible were a hernia mesh and a transvaginal
14 sling removed 3 and 10 months respectively after implantation. As shown further the
15 degradation layer is difficult to detect by light microscopy within the first year after
16 implantation.
17
18

1
2
3 adherent to the tissue [Figure 2(c)]. For descriptive purpose, the uniform circumferential
4 nature, fissuring and partial peeling of the layer resembled a tree bark.
5
6

FIGURE 2. Histological sections, H&E stain, 100x objective with oil immersion. The same cross section of a clear mesh fiber in regular (a) and polarized (b) light. The fiber has a layer of staining degraded polypropylene at the surface (between arrowheads). This layer has refractile properties of polypropylene in polarized light (b). In some areas the non-degraded core of the fibers detaches during histological processing while segments of the degraded layer stay attached to the tissue. Separated degradation layer in regular (c) and polarized (d) light. At sites like this, intensity of light passing through the degraded layer cannot be attributed to light scatter from the core. Note that tissue components including collagen have a much weaker birefringence than polypropylene (b and d).

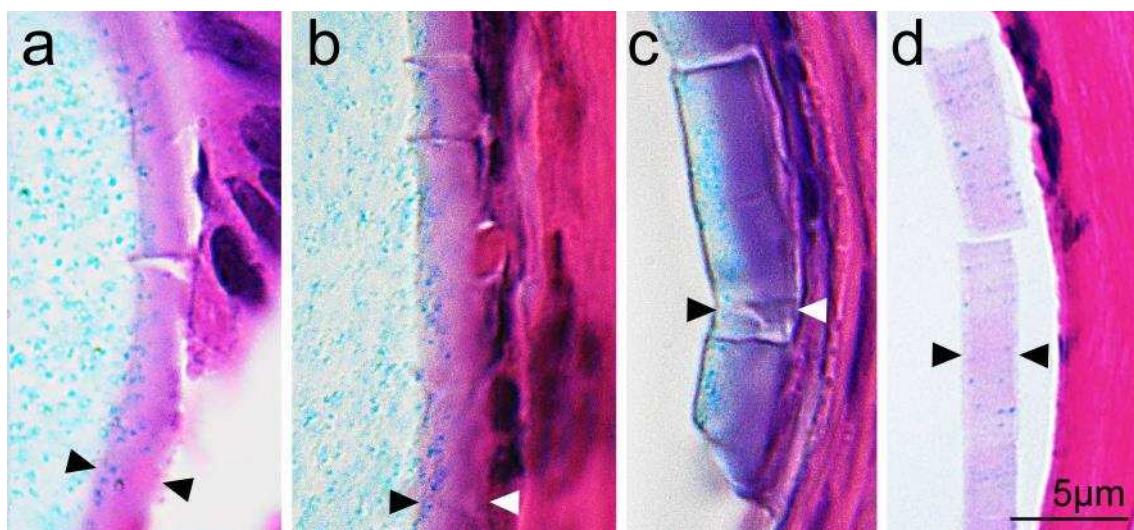
20 Several mesh designs on the market are knitted using a combination of clear and
21 blue fibers. In our pool of specimens, at least 50 explants showed blue fibers. Blue
22 polypropylene fibers incorporated a blue dye as granules introduced into the material
23 during its manufacture [Figure 3]. The granules were seen in the non-degraded core of
24 the fibers as well as to a variable degree in the outer degradation layer. In the latter,
25 they were detected within the “bark” remaining on the core [Figure 3(a&b)] as well as in
26 the segments of the “bark” separated from the core [Figure 3(c&d)]. The granules were
27 mainly seen in the deeper layers of the “bark” and were not as frequent closer to the
28 surface, which suggests that they also undergo degradation and lose color. The finding
29 was a direct confirmation that the “bark” originated from the same material as the core
30 of the fibers.
31

FIGURE 3. Degradation “bark” of the blue fibers manufactured with inclusion of blue dye granules, H&E stain, 100x objective with oil immersion: (a) and (b) non-degraded core (left half of the images) and the degraded layer (between arrowheads). Note that the blue granules are retained in the layer of degraded polypropylene. Within the degraded “bark”, the granules degrade and loose color toward the surface. In (c) and (d) the non-degraded core detached from the slides similarly to Figure 2(c and d). At these sites, presence of the granules in the separated “bark” cannot be attributed to an overlap with the core.

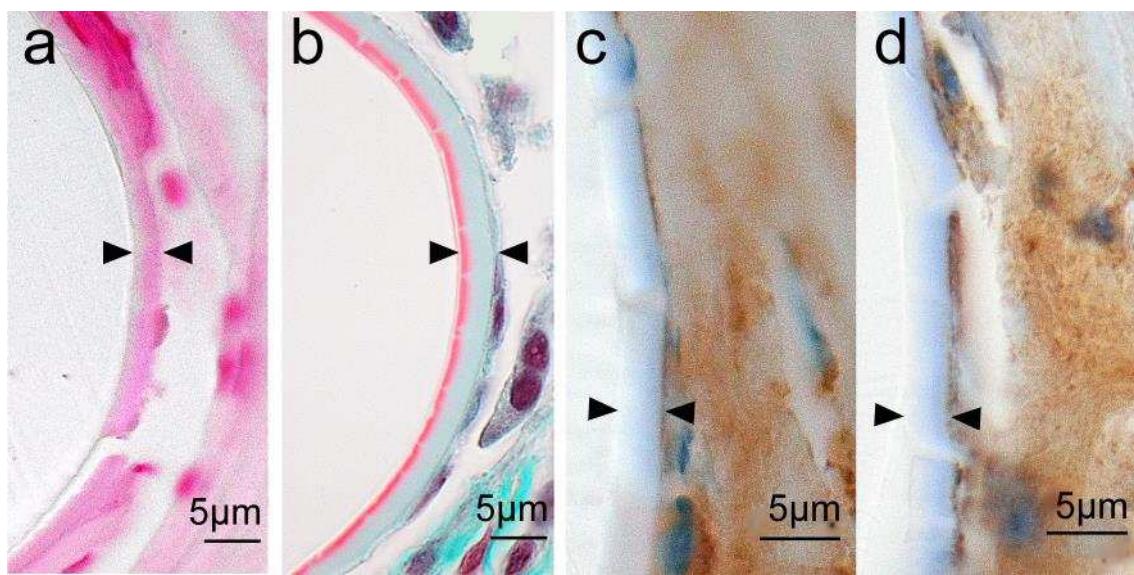
1
2
3 The brittleness, staining and birefringence characteristics of the “bark” were
4
5 similar to those of calcium salts which are commonly deposited in degenerating tissues.
6
7 Von Kossa stain was used for a sample set of 10 specimens to rule out presence of
8
9 calcium salts in the outer “bark”. No calcium salts were detected in the brittle outer layer
10
11 of the 10 specimens tested [Figure 4(a)].
12
13

1
2
3 deposited on the surface of the “bark”, but was not observed mixed within it [Figure
4
5 4(d)]. This finding further indicated incompatibility of the “bark” material with water-
6
7 soluble proteins. It also indicated an oxidative environment immediately around the
8
9 fibers.
10
11
12
13
14

FIGURE 4. Additional stains, all images taken with 100x oil immersion objective and cropped to a different magnification, polypropylene degradation layer is pointed between arrowheads: (a) Von Kossa stain is negative for calcium in the brittle "bark" (would stain calcium black), (b) trichrome stain shows that the deeper parts of the "bark" have smaller staining porosity (red) than those close to the surface (green) which correlates with TEM findings [Figure 6(b)], (c) immunohistochemical stain for immunoglobulin G (IgG, stained brown). IgG is present in almost all human tissues and fluids. It is deposited on the surface of degraded polypropylene but is not mixed within it. (d) Immunostain for the oxidizing enzyme of inflammatory cells myeloperoxidase (stains brown).

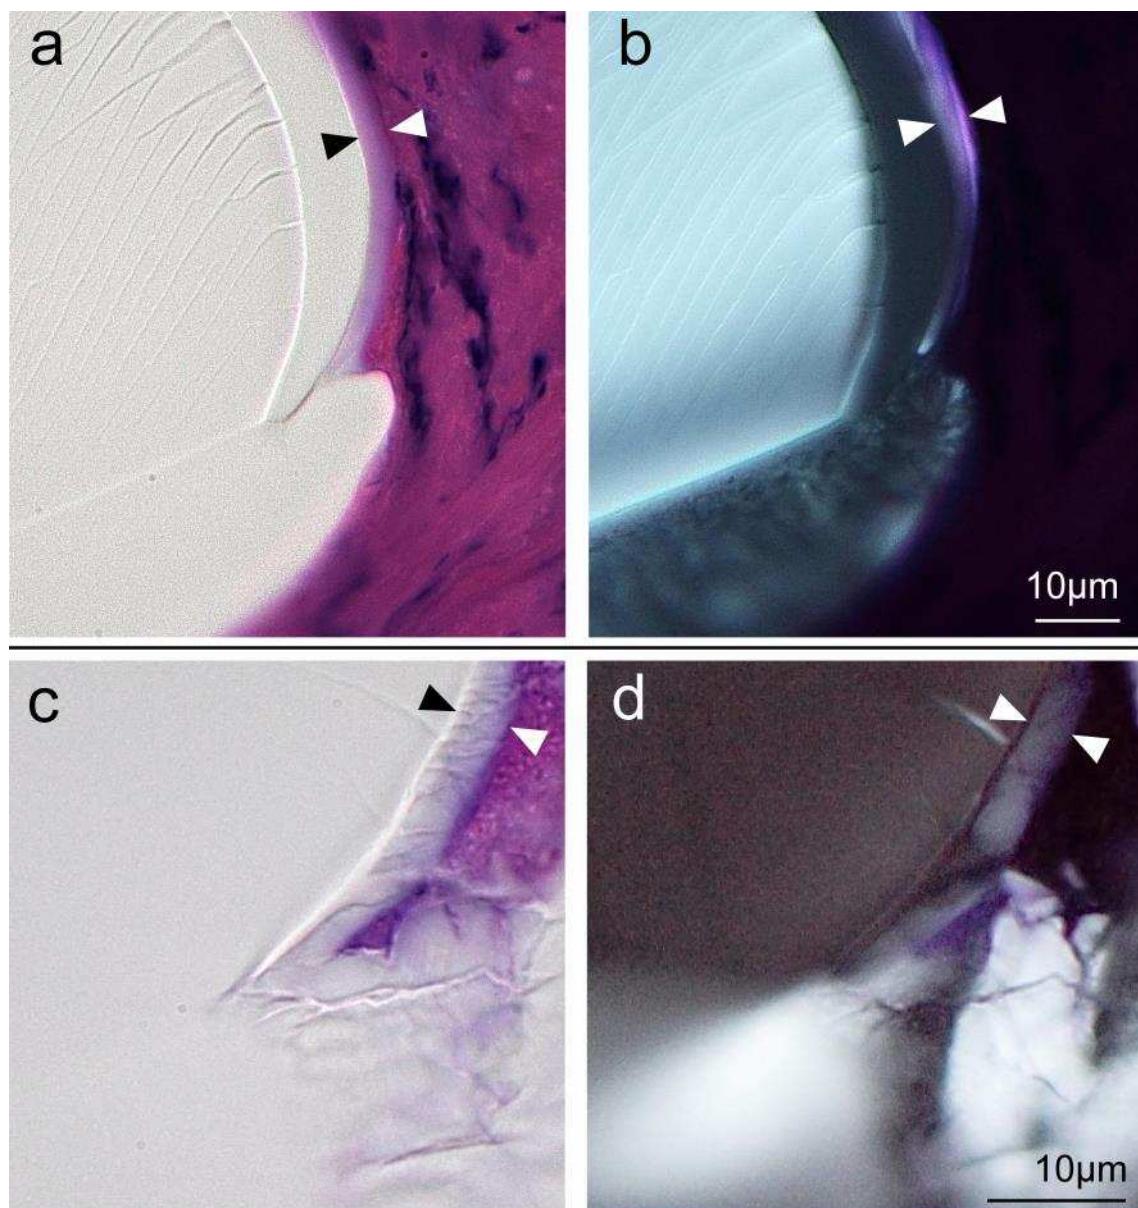
FIGURE 5. Melting of both non-degraded and degraded polypropylene caused by the surgical cautery, H&E, 100x oil immersion: (a) and (b) the same site of fiber melting in regular and polarized light, (c) and (d) another site showing melding point. While molten the non-degraded core and the degradation "bark" formed a common pool of material.

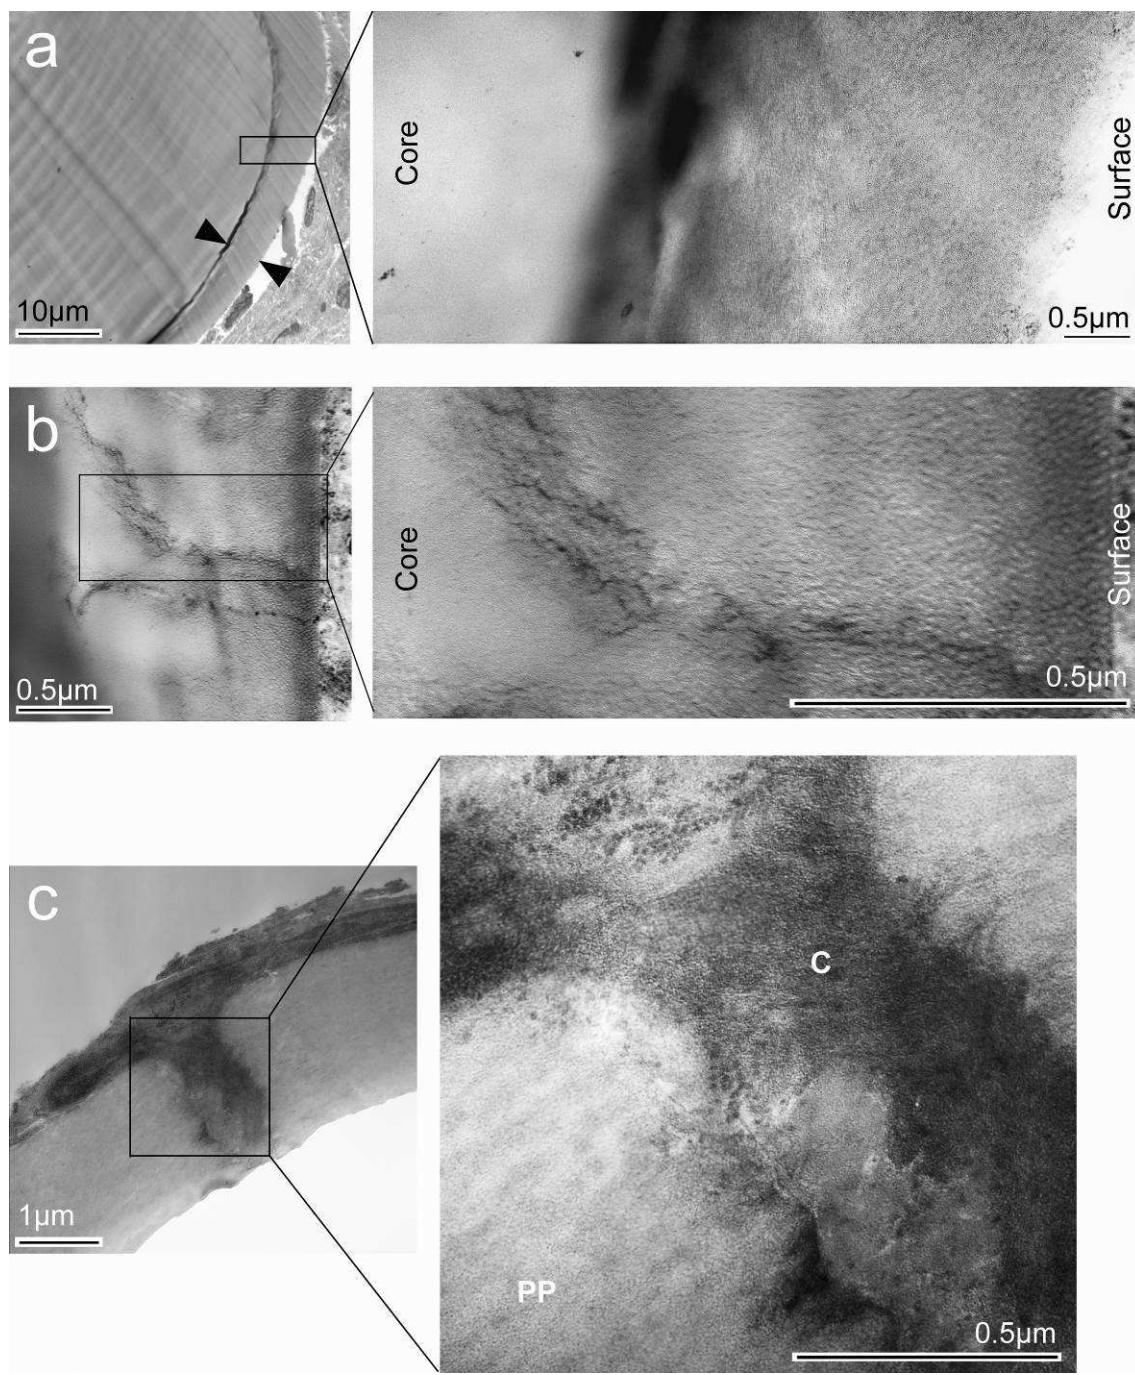
16 The “bark” either had a gradual transition into the core [Figure 6(b)] or showed a
17 zone of circumferential fissuring partially separating it from the core [Figure 6(a)]. The
18 mechanisms of “bark” separation from the core and formation of the larger cracks are
19 likely linked since the cracks tended to turn at the interface between the “bark” and the
20 core [Figure 6(b)]. The forces which produced the transverse (radial) cracks also acted
21 as shear forces between the “bark” and the core.
22
23

24 An important finding was the detection of inflammatory cells partially migrated
25 into and trapped within the fissures as shown in Figure 6(c). The shape of widened
26 crevices and the depth of penetration indicated an active *in vivo* cellular migration. This
27 phenomenon was observed at two separate sites.
28
29

FIGURE 6. Transmission electron microscopy. (a) Low power magnification of a cross-sectioned mesh fiber shows the degradation layer similarly to light microscopy, the insert shows an image composed of three high power fields to reconstruct the transition between the non-degraded core and the degradation "bark". Note the fine nanocracks/nanopores in the degraded material. (b) Outer part of the fiber with gradual transition between the non-degraded core and the degraded polypropylene at the surface. The lattice of nanocracks expands towards the surface (left to right). There are also two larger cracks which start perpendicular to the surface but then turn at the

1
2
3 interface between the core and the degraded layer. (c) A part of inflammatory cell
4 (labeled C in insert) is trapped in a fissure within the degraded polypropylene (PP).
5 Higher magnification (insert) shows cellular membrane at the cell-polypropylene
6 interface (left wall of the fissure) and cellular organelles in the cell (chains of rounded
7 structures, likely ribosomes).
8
9
10
11
12
13
14
15
16
17
18
19
20
21
22
23
24
25
26
27
28
29
30
31
32
33
34
35
36
37
38
39
40
41
42
43
44
45
46
47
48
49
50
51
52
53
54
55
56
57
58
59
60

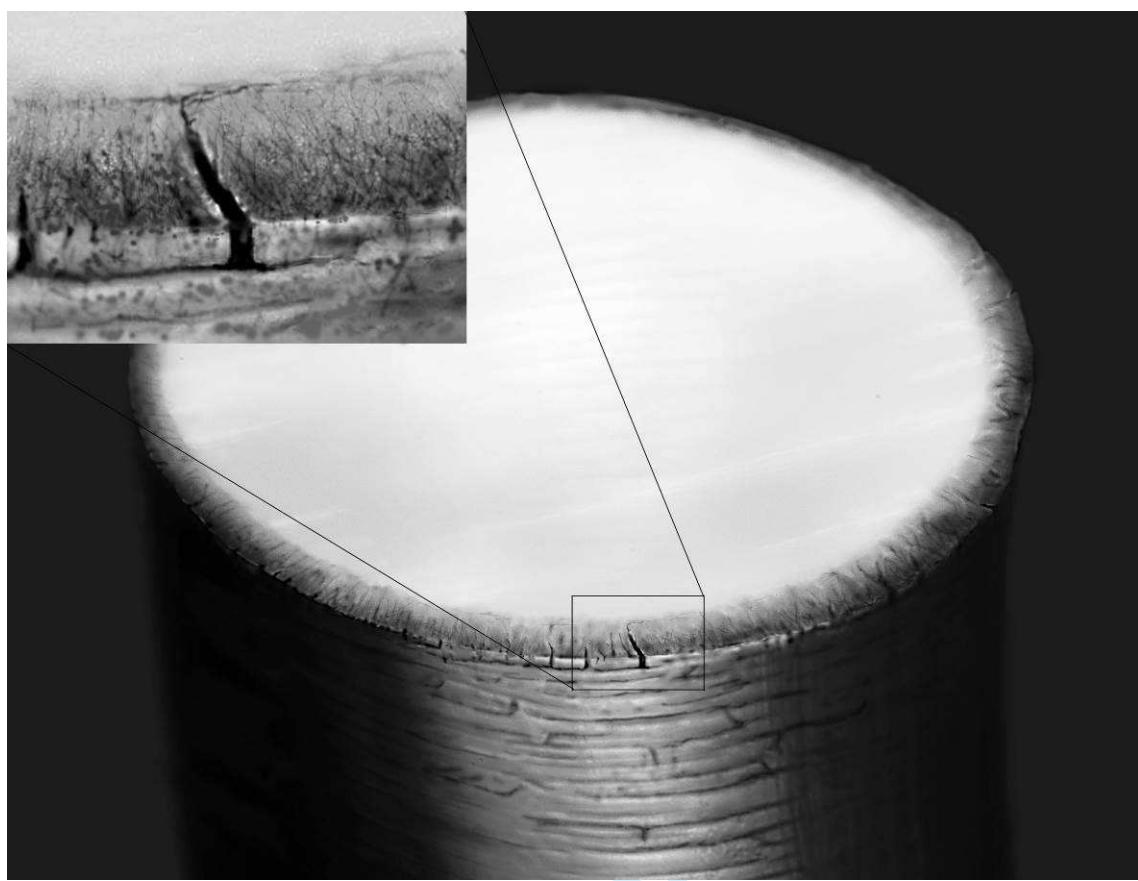
30 For better demonstration of the degradation “bark” we used light microscopic and
31 TEM images to generate a 3-dimensional restoration of a mesh fiber [Figure 7].
32
33
34
35
36
37
38
39
40
41
42
43
44
45
46
47
48
49
50
51
52
53
54
55
56
57
58
59
60

FIGURE 7. A 3-dimensional restoration of a cross sectioned mesh fiber.

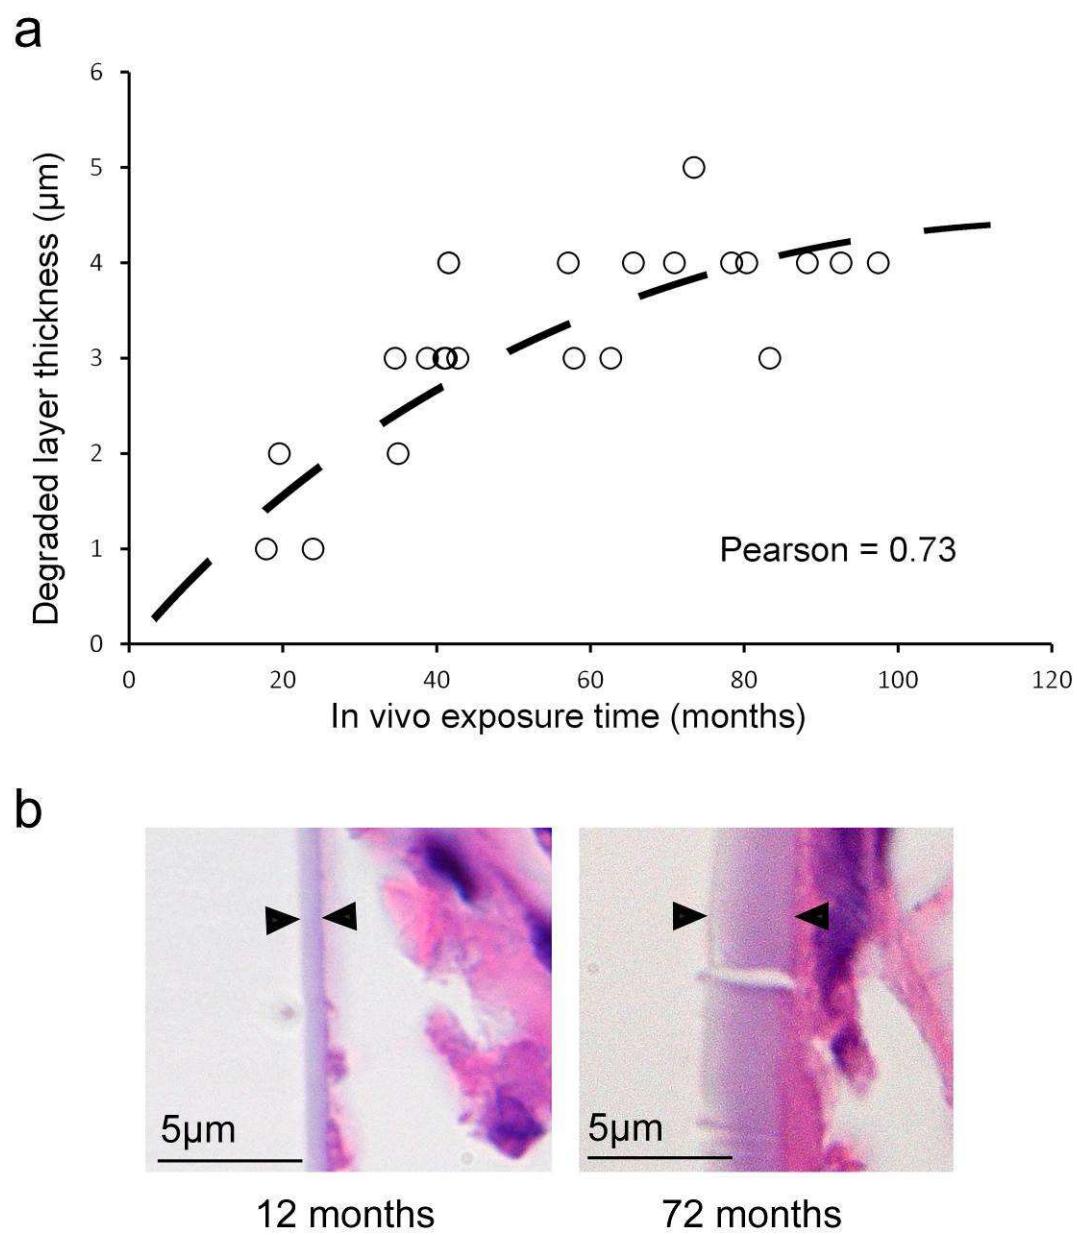
Out of all the specimens, 23 samples of explanted midurethral slings formed the largest group of meshes from the same manufacturer, of identical mesh type and with reliable records of implantation and excision dates. The range of *in vivo* interval (between implantation to excision) in the group was 18 to 97 months (mean 53). There was a good correlation (Pearson = 0.73) between the thickness of the degradation layer and the duration of *in vivo* exposure indicating that the thickness of degraded material grows while the mesh is in the body [Figure 8(a&b)]. There was a trend for a more rapid initial growth with gradual plateau subsequently.

FIGURE 8. Duration of *in vivo* exposure vs. thickness of degraded layer in a group of explants of the same manufacturer and the same mesh design. (a) Thickness of the degradation “bark” increased over the years *in vivo* (Pearson correlation = 0.73). Note the trend of plateauing after 5-6 years. There was no correlation of the thickness with the duration of specimen storage in formalin (not shown, Pearson = -0.06). (b) Comparison of the “bark” in meshes explanted after 12 and 72 months in the body, H&E, 100x objective with oil immersion, images cropped to the same magnification factor.

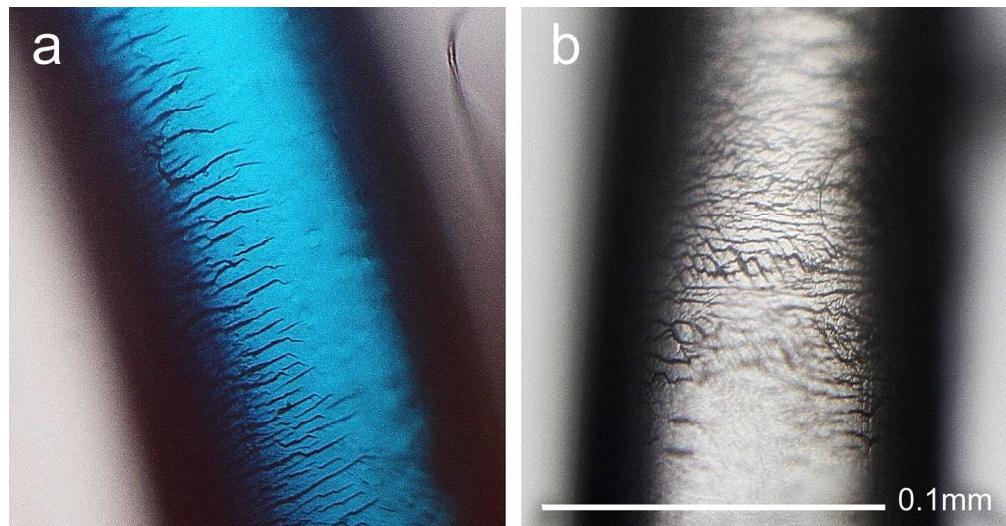
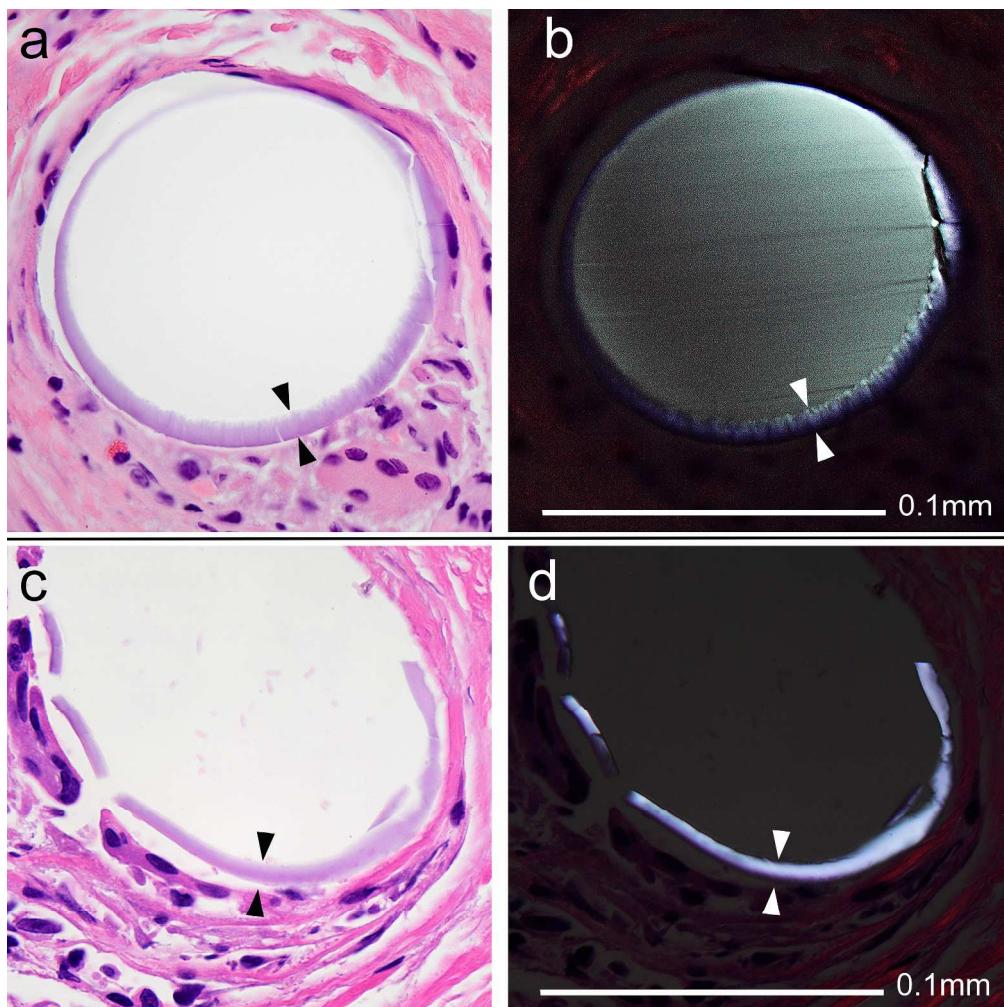
FIGURE 1. Surface of the mesh fibers immediately after explantation from the body, transvaginal sling explanted due to pain 9 years after implantation, light microscope, 20x objective with image crop. Mesh fibers at the specimen edges had no covering tissue and could be examined as they were in the body, avoiding possible artifacts of tissue removal, drying or contact with formalin. Both blue (a) and clear (b) fibers showed surface cracking.

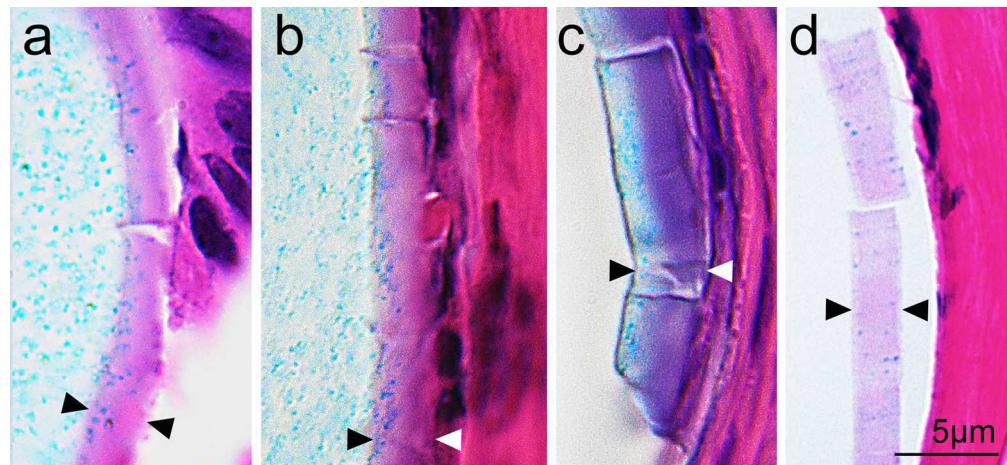
FIGURE 3. Degradation "bark" of the blue fibers manufactured with inclusion of blue dye granules, H&E stain, 100x objective with oil immersion: (a) and (b) non-degraded core (left half of the images) and the degraded layer (between arrowheads). Note that the blue granules are retained in the layer of degraded polypropylene. Within the degraded "bark", the granules degrade and loose color toward the surface. In (c) and (d) the non-degraded core detached from the slides similarly to Figure 2(c and d). At these sites, presence of the granules in the separated "bark" cannot be attributed to an overlap with the core.

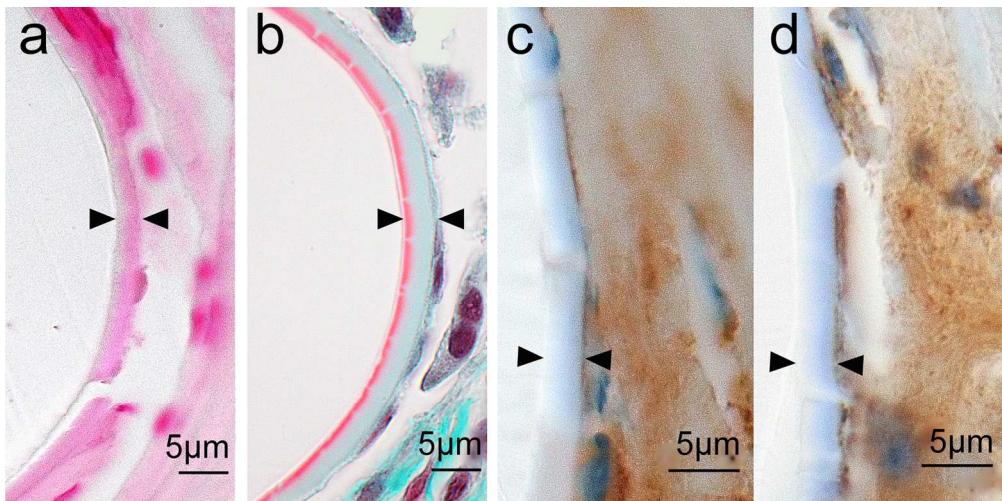
FIGURE 4. Additional stains, all images taken with 100x oil immersion objective and cropped to a different magnification, polypropylene degradation layer is pointed between arrowheads: (a) Von Kossa stain is negative for calcium in the brittle "bark" (would stain calcium black), (b) trichrome stain shows that the deeper parts of the "bark" have smaller staining porosity (red) than those close to the surface (green) which correlates with TEM findings [Figure 6(b)], (c) immunohistochemical stain for immunoglobulin G (IgG, stained brown). IgG is present in almost all human tissues and fluids. It is deposited on the surface of degraded polypropylene but is not mixed within it. (d) Immunostain for the oxidizing enzyme of inflammatory cells myeloperoxidase (stains brown).

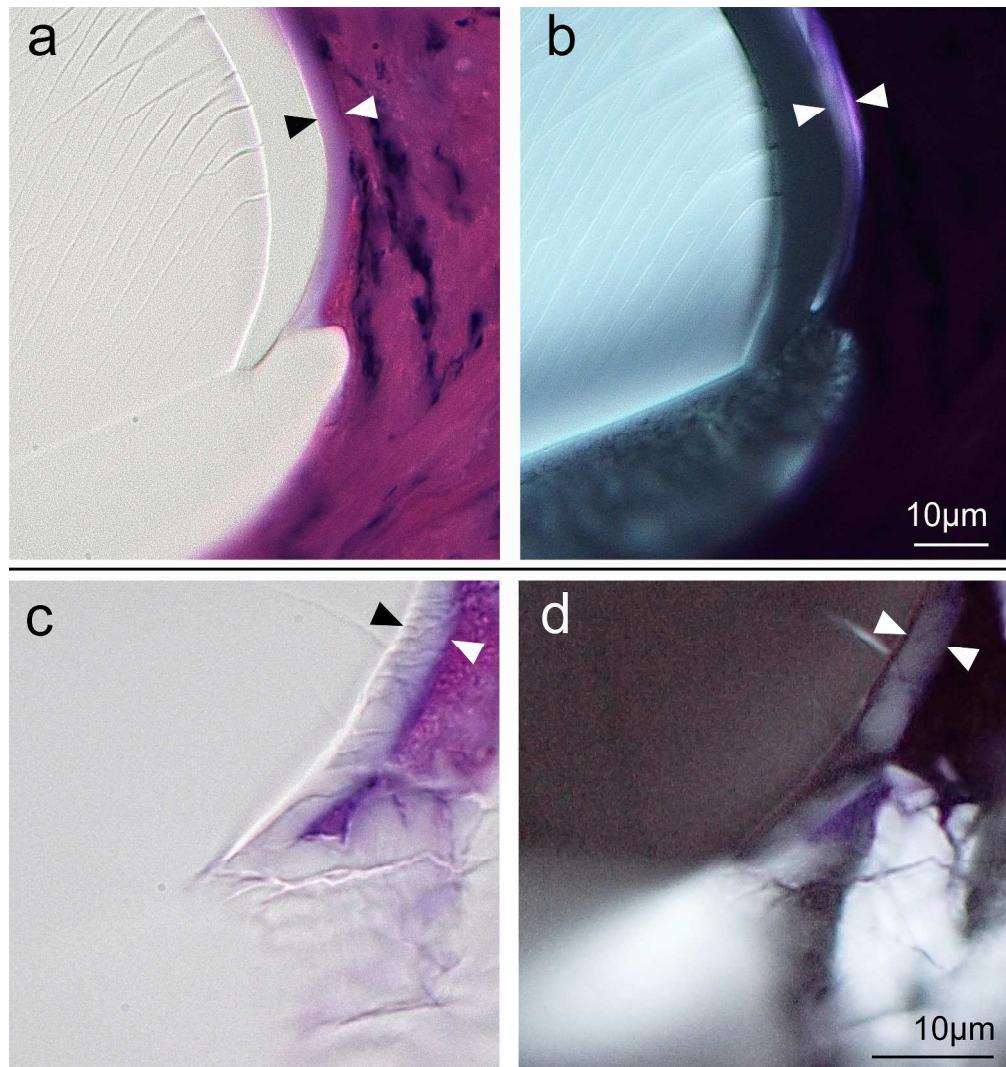
FIGURE 5. Melting of both non-degraded and degraded polypropylene caused by the surgical cautery, H&E, 100x oil immersion: (a) and (b) the same site of fiber melting in regular and polarized light, (c) and (d) another site showing melding point. While molten the non-degraded core and the degradation "bark" formed a common pool of material.
159x169mm (600 x 600 DPI)

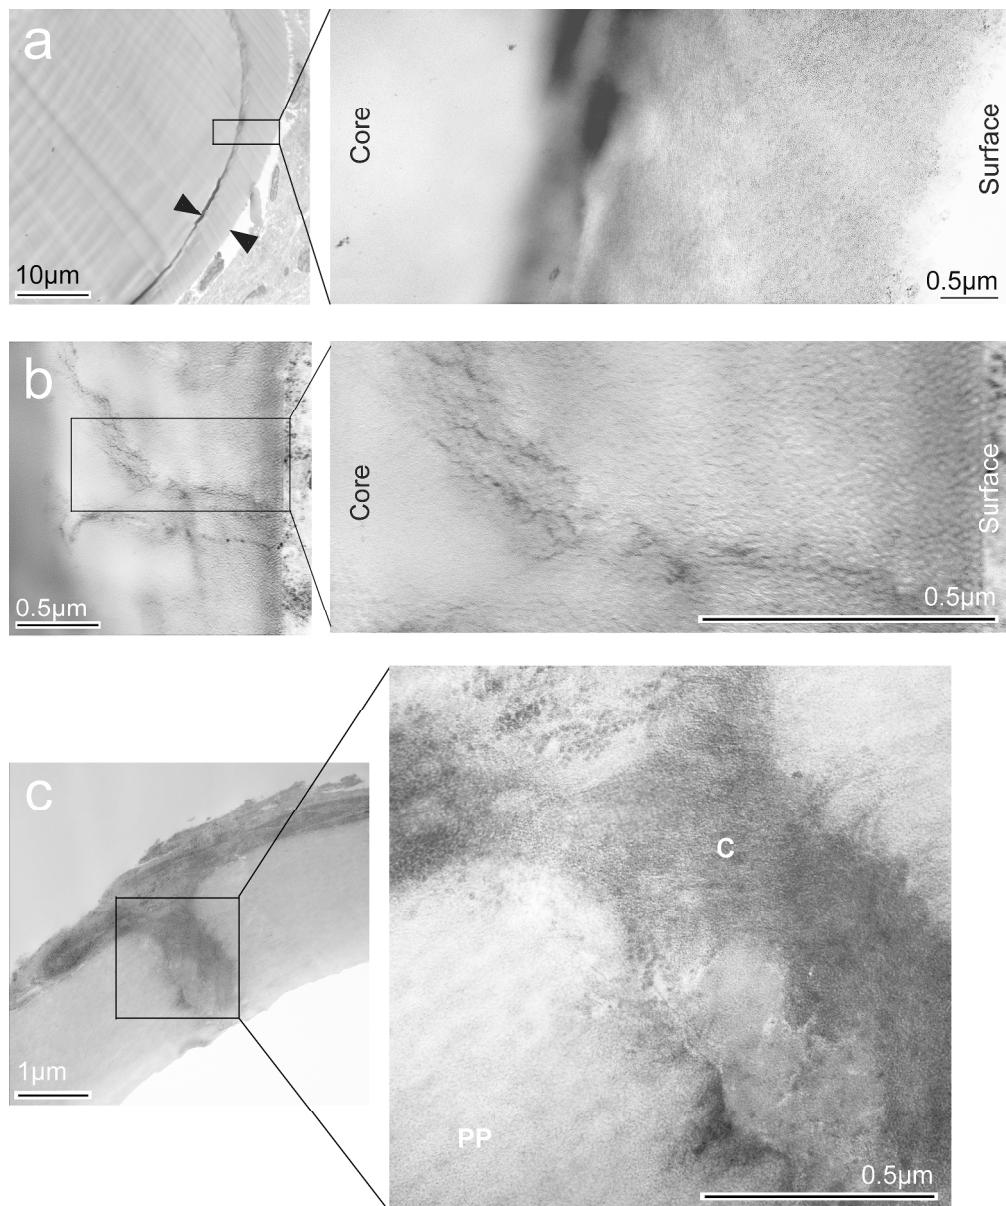
FIGURE 6. Transmission electron microscopy. (a) Low power magnification of a cross-sectioned mesh fiber shows the degradation layer similarly to light microscopy, the insert shows an image composed of three high power fields to reconstruct the transition between the non-degraded core and the degradation "bark". Note the fine nanocracks/nanopores in the degraded material. (b) Outer part of the fiber with gradual transition between the non-degraded core and the degraded polypropylene at the surface. The lattice of nanocracks expands towards the surface (left to right). There are also two larger cracks which start perpendicular to the surface but then turn at the interface between the core and the degraded layer. (c) A part of inflammatory cell (labeled C in insert) is trapped in a fissure within the degraded polypropylene (PP). Higher magnification (insert) shows cellular membrane at the cell-polypropylene interface (left wall of the fissure) and cellular organelles in the cell (chains of rounded structures, likely ribosomes).

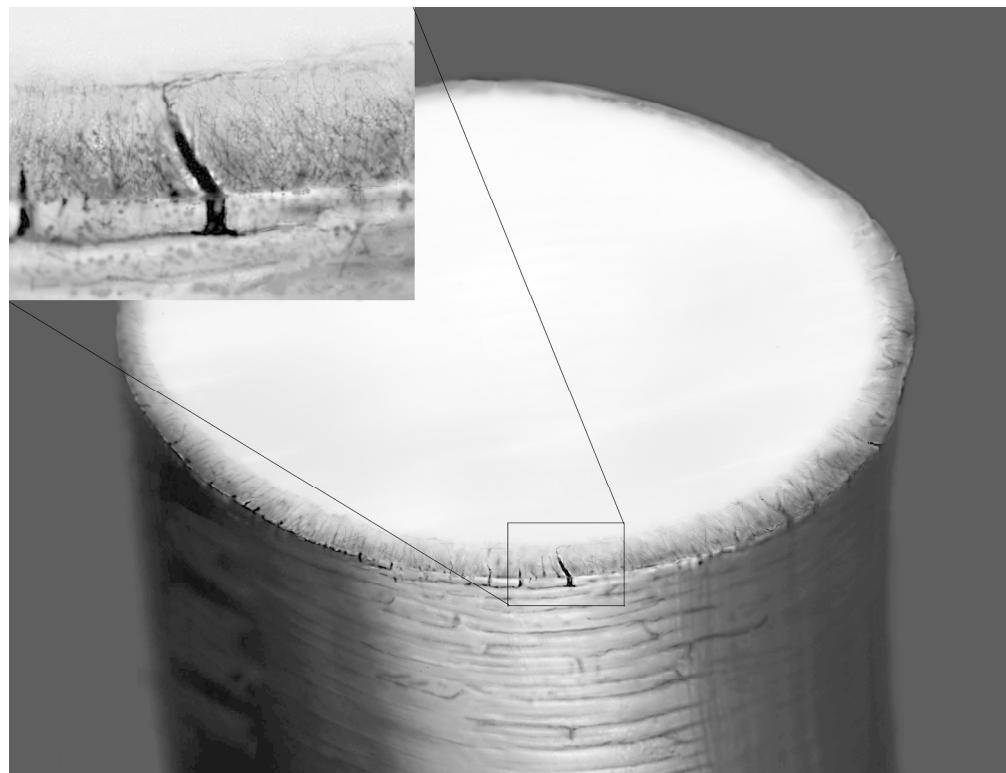
FIGURE 7. A 3-dimensional restoration of a cross sectioned mesh fiber.
114x88mm (600 x 600 DPI)

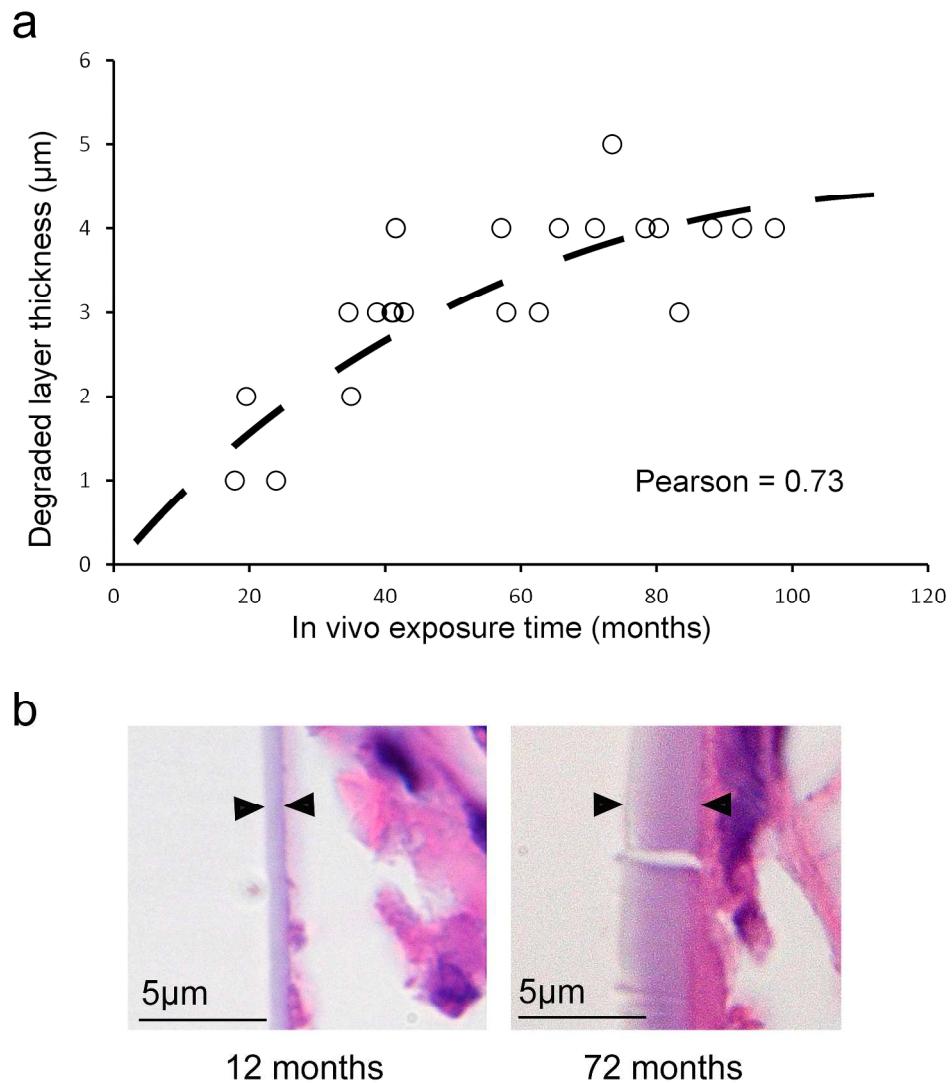
FIGURE 8. Duration of in vivo exposure vs. thickness of degraded layer in a group of explants of the same manufacturer and the same mesh design. (a) Thickness of the degradation "bark" increased over the years in vivo (Pearson correlation = 0.73). Note the trend of plateauing after 5-6 years. There was no correlation of the thickness with the duration of specimen storage in formalin (not shown, Pearson = -0.06). (b) Comparison of the "bark" in meshes explanted after 12 and 72 months in the body, H&E, 100x objective with oil immersion, images cropped to the same magnification factor.
